**Flood Control Project Maintenance
Levee Inspections**

Maintenance Issue Types Only, Levee Inspection Report By Mile - Fall 2018

Sutter Maintenance Yard Nelson Bend

Waterway	Bank	Unit Miles	Inspection Start/End	Inspector
Unit No. 01 Feather River West Levee - Nelson Bend		0.50	09/18/2018 09/18/2018	Sterling York

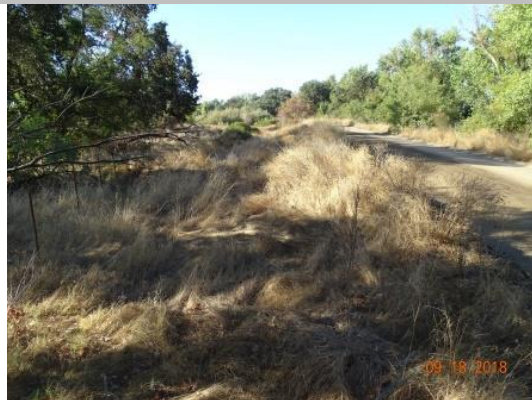
Photo 1 of 2 : FA_2018_ST0006_471_15_20181003_00014.jpg

LM Start	0.02	Rating **	U	Issue No.	15
LM End	0.42	Issue Type +	Ma	Location *	WS
Category	Earthen Levee			GPS Latitude/Longitude	
				Start	End
Item	Vegetation			38.886883 °	38.881287 °
				-121.614797 °	-121.614490 °
DWR ID	DWR_ST0006_01_f_2015_15				
Comment Code					
V2 : Remove the wild growth other than native grasses from the levee slopes.					
Inspector Comment					
Remove the annual vegetation and wild growth. Fall 2018.

View of the vegetation along the waterside slope looking downstream, Fall 2018.

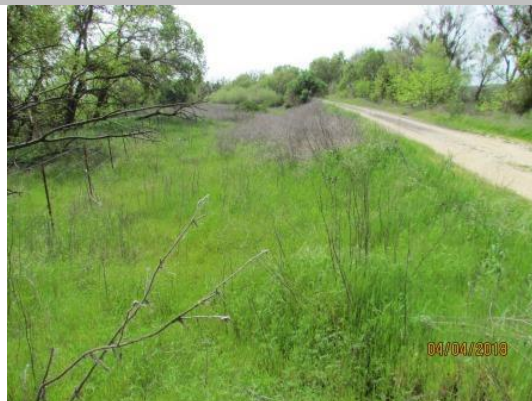
Photo 2 of 2 : FA_2018_ST0006_471_15_20180918_00006.jpg

LM Start	0.02	Rating **	U	Issue No.	15 (cont)
LM End	0.42	Issue Type +	Ma	Location *	WS

View of the vegetation along the waterside slope looking downstream, Spring 2018.

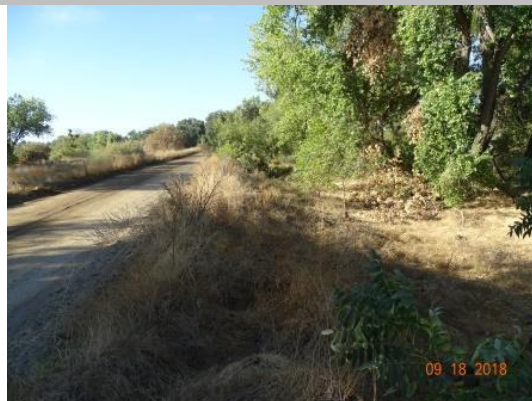
Photo 1 of 2 : FA_2018_ST0006_471_2_20181003_00015.jpg

LM Start	0.02	Rating **	U	Issue No.	2
LM End	0.46	Issue Type +	Ma	Location *	LS
Category	Earthen Levee			GPS Latitude/Longitude	
				Start	End
Item	Vegetation			38.886883 °	38.880833 °
				-121.614797 °	-121.614387 °
DWR ID	DWR_ST0006_01_f_2015_2				
Comment Code					
V2 : Remove the wild growth other than native grasses from the levee slopes.					
Inspector Comment					
Remove the annual vegetation and wild growth. Fall 2018.

View of the vegetation along the landside slope looking downstream, Fall 2018.

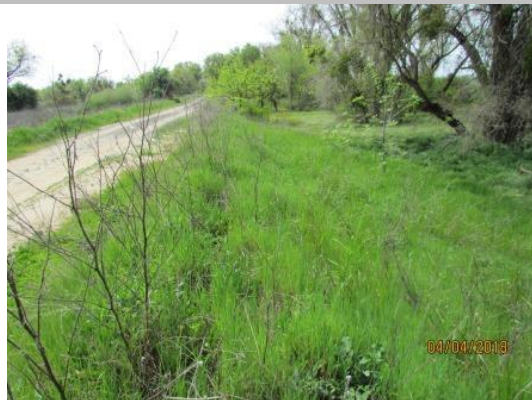
Photo 2 of 2 : FA_2018_ST0006_471_2_20180918_00002.jpg

LM Start	0.02	Rating **	U	Issue No.	2 (cont)	
LM End	0.46	Issue Type +	Ma	Location *	LS	
Category	Earthen Levee			GPS Latitude/Longitude		
				Start		End
Item	Vegetation			38.886883 °		38.880833 °
				-121.614797 °		-121.614387 °
DWR ID	DWR_ST0006_01_f_2015_2					
Comment Code						
V2 : Remove the wild growth other than native grasses from the levee slopes.						
Inspector Comment						
Remove the annual vegetation and wild growth. Fall 2018.

View of the vegetation along the landside slope looking downstream, Spring 2018.

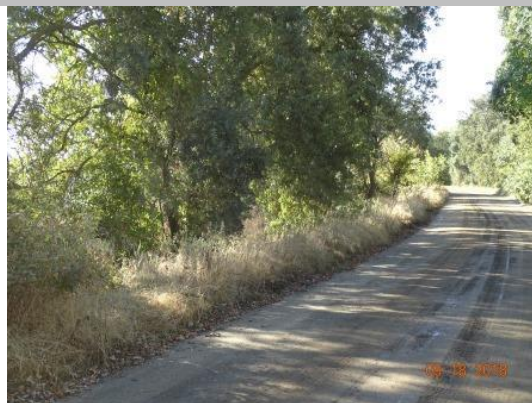
Photo 1 of 2 : FA_2018_ST0006_471_1_20181003_00016.jpg

LM Start	0.13	Rating **	U	Issue No.	1
LM End	0.50	Issue Type +	Ma	Location *	WS
Category	Earthen Levee			GPS Latitude/Longitude	
				Start	End
Item	Trim / Thin Trees			38.885396°	38.880295°
				-121.615595°	-121.614147°
DWR ID	DWR_ST0006_01_f_2017_1				
Comment Code					
T3 : Trim and thin trees to allow visibility of the ground and room to flood fight.					
Inspector Comment					
Trim up the trees 5 feet for access and visibility, Fall 2018.

View looking downstream waterside of the over growth of trees, Fall 2018.

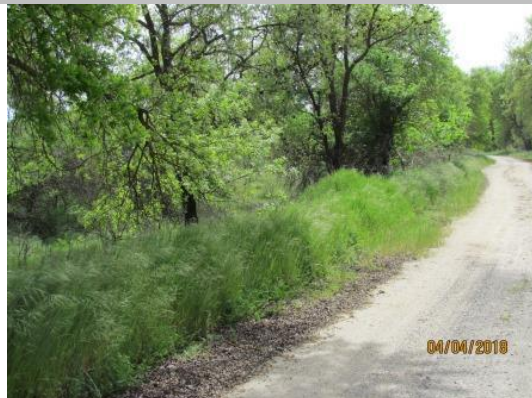
Photo 2 of 2 : FA_2018_ST0006_471_1_20180918_00001.jpg

LM Start	0.13	Rating **	U	Issue No.	1 (cont)	
LM End	0.50	Issue Type +	Ma	Location *	WS	
Category	Earthen Levee			GPS Latitude/Longitude		
				Start		End
Item	Trim / Thin Trees			38.885396°		38.880295°
				-121.615595°		-121.614147°
DWR ID	DWR_ST0006_01_f_2017_1					
Comment Code						
T3 : Trim and thin trees to allow visibility of the ground and room to flood fight.						
Inspector Comment						
Trim up the trees 5 feet for access and visibility, Fall 2018.

View looking downstream waterside of the over growth of trees, Spring 2018.

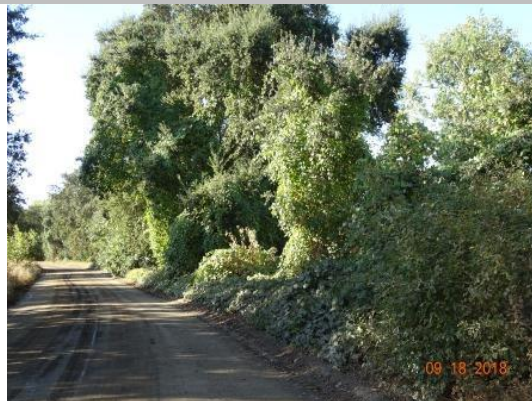
Photo 1 of 2 : FA_2018_ST0006_471_3_20181003_00017.jpg

LM Start	0.13	Rating **	U	Issue No.	3
LM End	0.50	Issue Type +	Ma	Location *	LS
Category	Earthen Levee			GPS Latitude/Longitude	
				Start	End
Item	Trim / Thin Trees			38.885396 °	38.880295 °
				-121.615595 °	-121.614147 °
DWR ID	DWR_ST0006_01_f_2017_3				
Comment Code					
T3 : Trim and thin trees to allow visibility of the ground and room to flood fight.					
Inspector Comment					
Trim up the trees 5 feet for access and visibility, Fall 2018.

View looking downstream landside of the over growth of trees, Fall 2018.

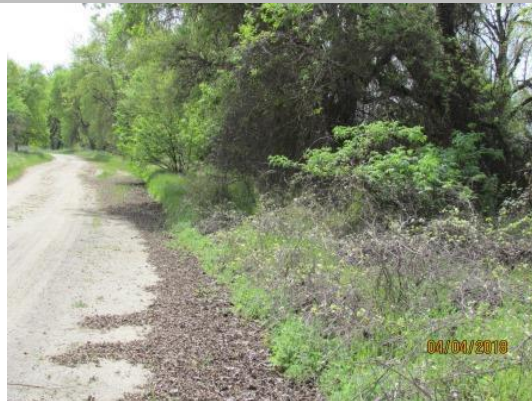
Photo 2 of 2 : FA_2018_ST0006_471_3_20180918_00003.jpg

LM Start	0.13	Rating **	U	Issue No.	3 (cont)
LM End	0.50	Issue Type +	Ma	Location *	LS

View looking downstream landside of the over growth of trees, Spring 2018.
